Print Quality/Poor Transfer

HP CLJ M552/M553/M577MFP/E55040/E57540MFP

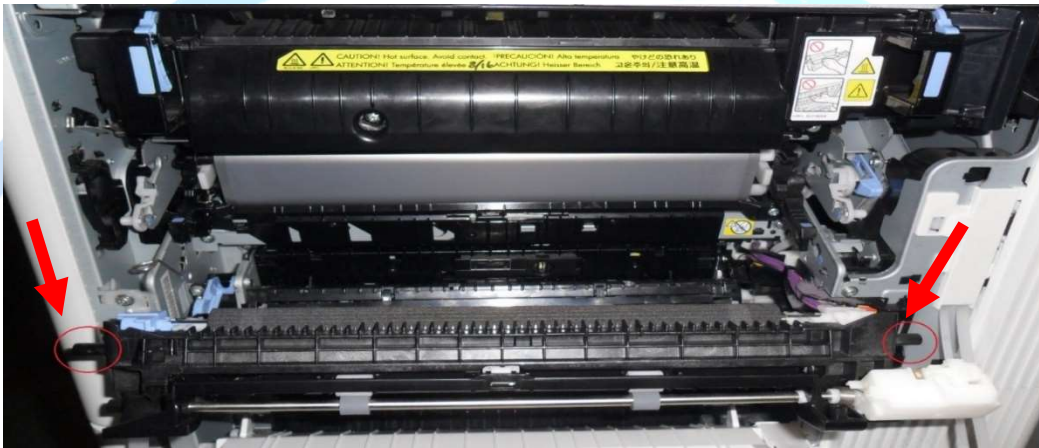
Laser Pros International has had numerous cases where a tab (or tabs) on the secondary transfer assembly break. Depending on which tab(s) has been broken, it will result in faded or washed out print on either the left or right side of the page, or across the entire page if both tabs are broken.

Figure 1: Example showing both tabs correct/not broken.

Secondary transfer assembly replacement #: RM2-0022 Duplex models, RM2-0090 Simplex models.

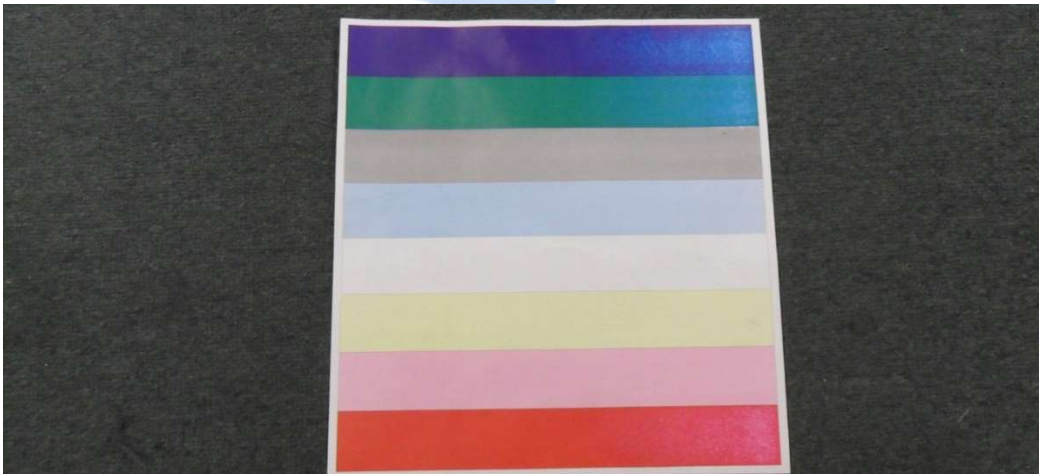
There are two locking mechanisms in the printer that secure these two tabs and pull the secondary transfer assembly tight against the transfer belt as the right door is closed. If either of the tabs break, the printer will lose the ability to properly transfer toner to the side where the tab has broken.

Figure 2: Example of “color band test” shown faded down right side from a printer that had the front tab broken.
