59.F0 Error

HP CP3525/CM3530/M551/M575

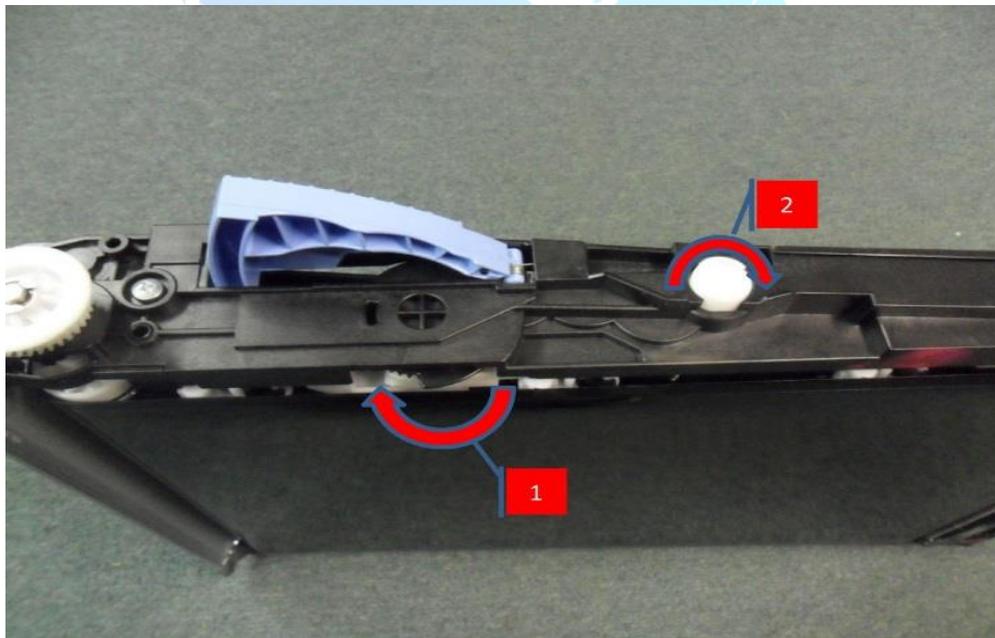
1. Reseat the ITB and power cycle the printer.
2. If issue persists, remove the ITB completely from the printer and inspect the ITB.
 - a. Check to see if the ITB flag rotates (callout 1) when the white knob is turned (callout 2).

- b. If the ITB flag is broken, damaged or does not rotate, replace the ITB (CC468-67907).
 - c. If the ITB flag is not broken or damaged, continue to step 3
3. Test the primary transfer roller disengagement sensor SR17 in the MANUAL SENSOR TEST.
 - a. NOTE: Before initiating this test, remove the Fuser, ITB, cyan cartridge and black cartridge from the unit.

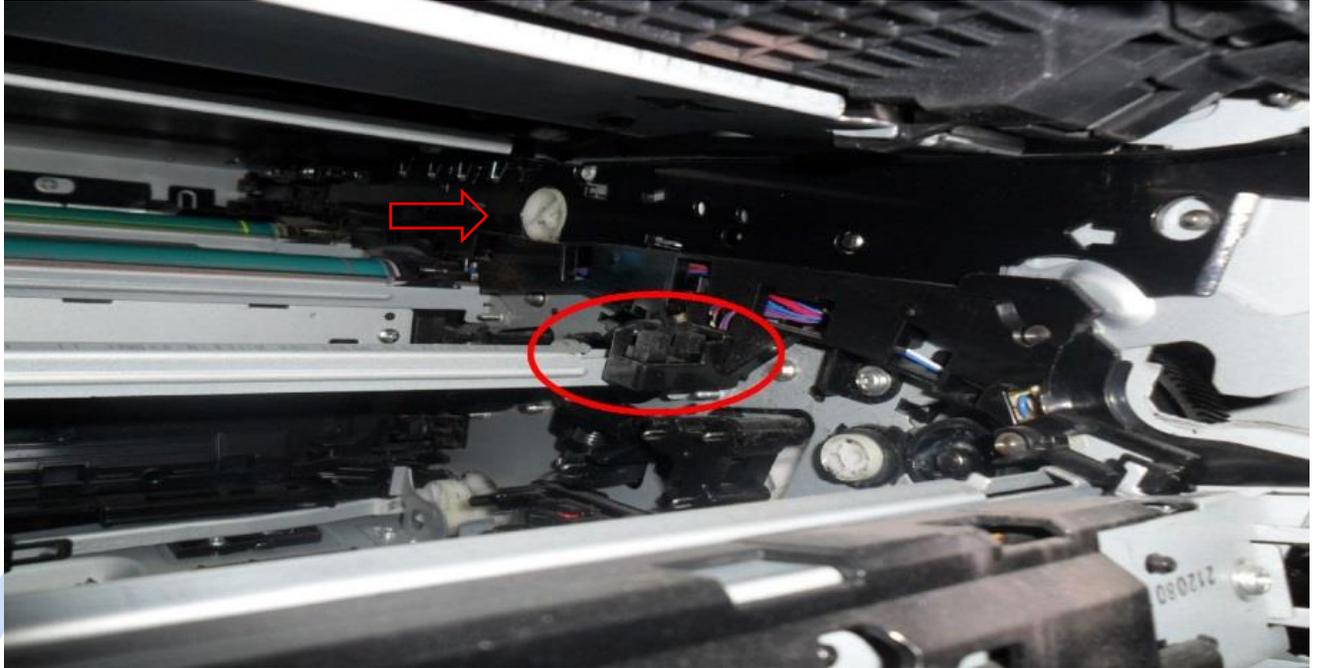
- b. Access Trouble Shooting /Diagnostics Menu from the printer control panel
- c. Press the down arrow to highlight “MANUAL SENSOR TEST” and then press the OK button
- d. Observe the state of sensor “I” on the control panel (The normal state is 0).
- e. Locate SR17 through the right side of the printer.
 - It is attached to the frame of the printer just about the end of the black cartridge (where it makes contact with the frame). Location of SR17 (circled) in image below.

- d. During the test (about 20 seconds), observe the white alienation drive hub located above the Cyan cartridge (shown with the arrow in the figure above).

- ii. If the value for sensor letter “I” does not change, the sensor will need to be cleaned or replaced (Photo interrupter SR17 WG8-5696).
4. If Sensor SR17 is working properly, open the right door and defeat the interlock switch. With the ITB removed, perform the ITB contact/Alienation test.

5. If the alienation drive hub does not rotate, the fuser drive is most likely the problem. Replace the fuser drive assembly.
 - a. CP3525/CM3530:
 - i. For duplex models: RM1-4974
