“LOAD PAPER” message or “60.02” error codes

HP CLJ M377MFP/M452/M454/M477MFP/M479MFP

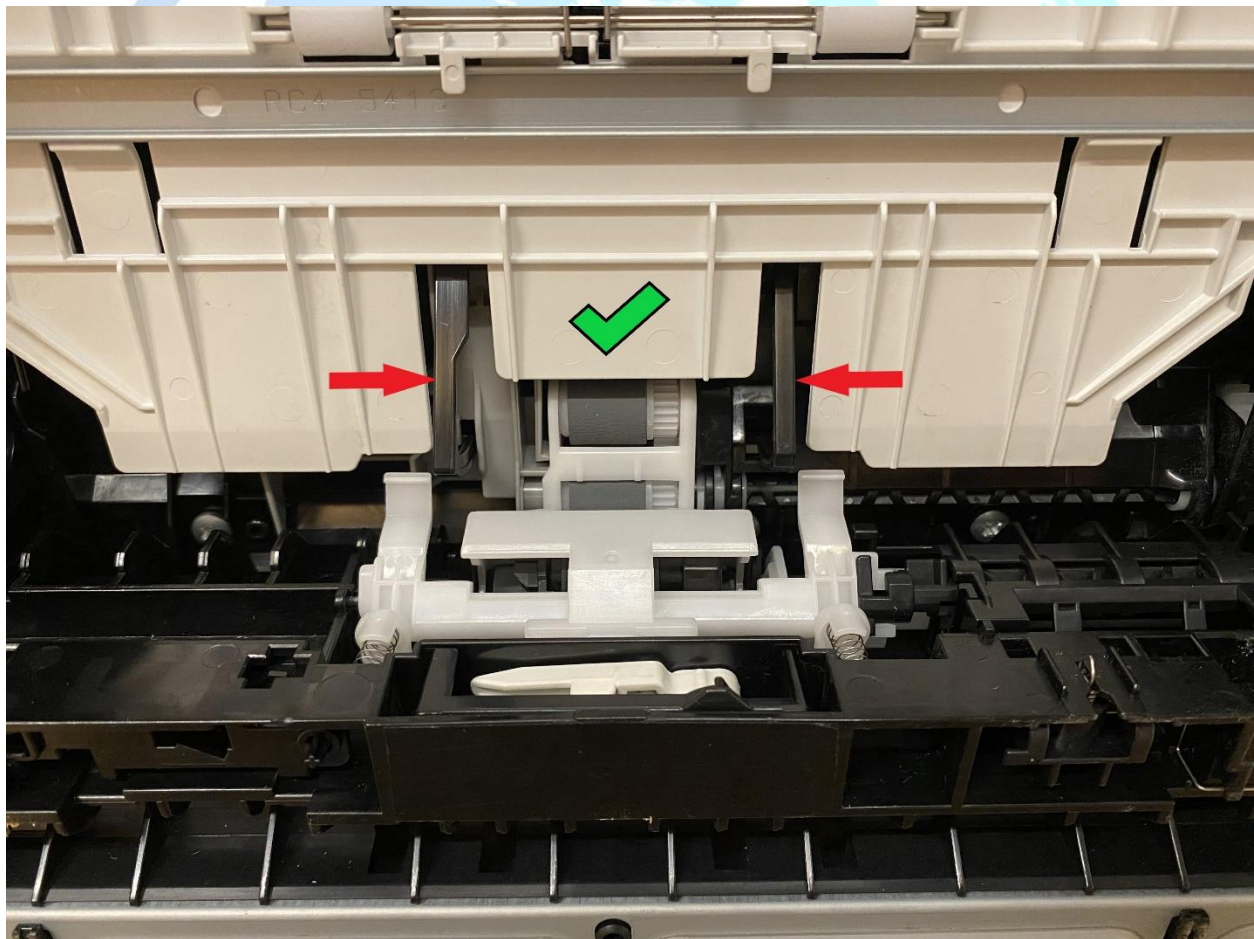
There are two black plastic sensor flags on either side of the pick-up roller that we have seen lodged or out of position, causing these codes.

Figure 1: Flags shown in correct position:

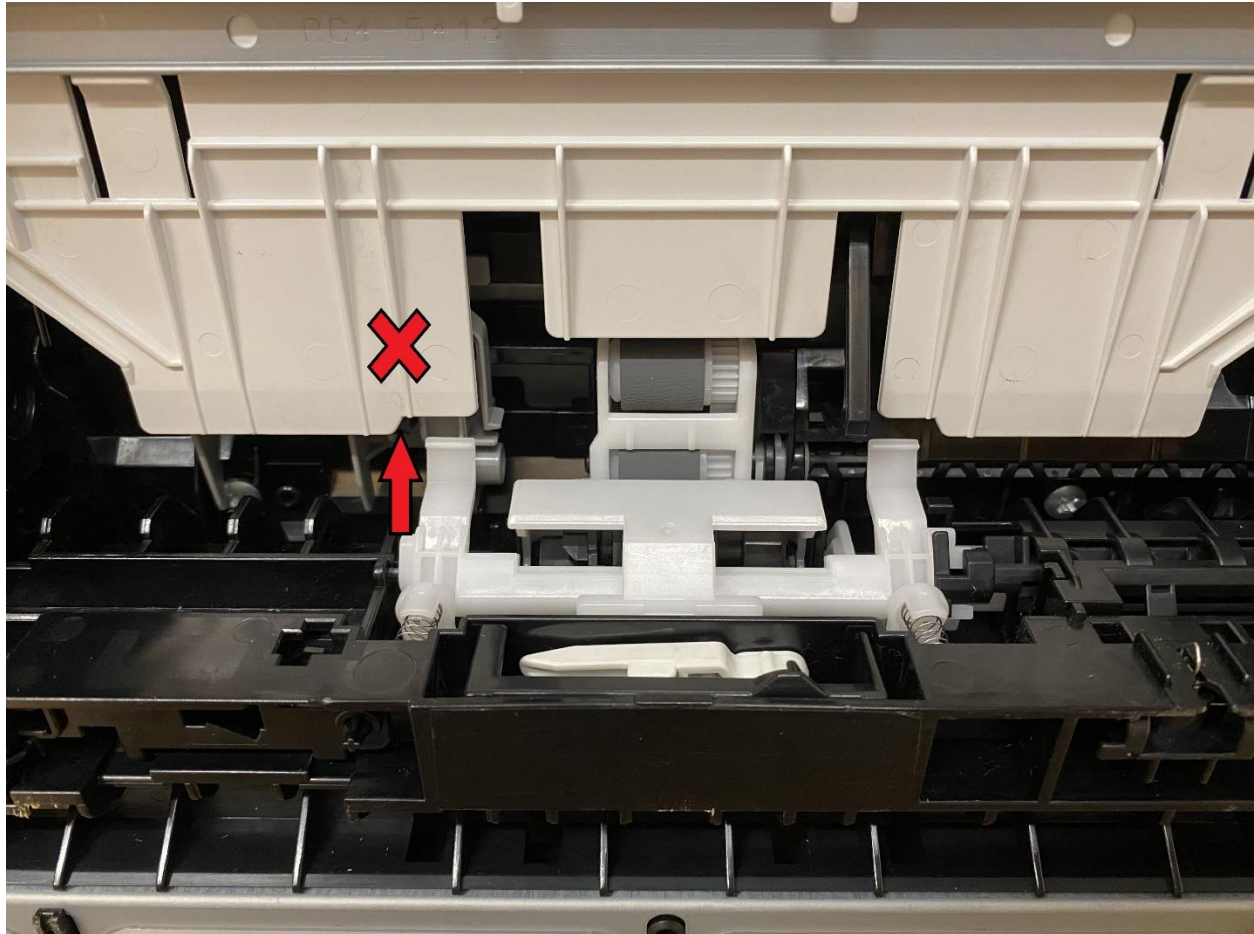
The flag located on the left side of the pick-up roller is part of the slide that locks the roller into place. This has been known to work its way left from printer use, removing paper jams, etc. After working its way left, the flag will then causing the “LOAD PAPER” message on the control panel.

Figure 2: The pick-up roller lock slide shown out of position:

This can usually be resolved simply by sliding the lock to the right until it clicks into place.

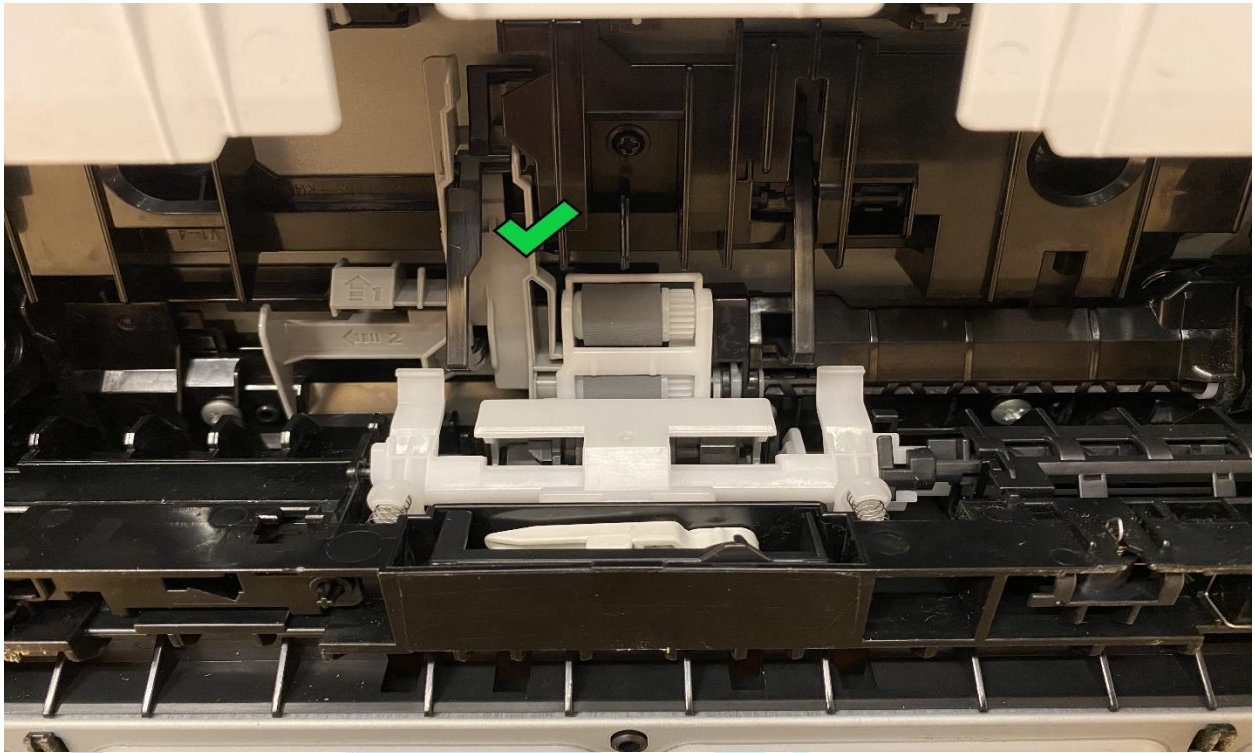
Figure 3: Duplex tray shown lowered and roller lock in correct position (locked):

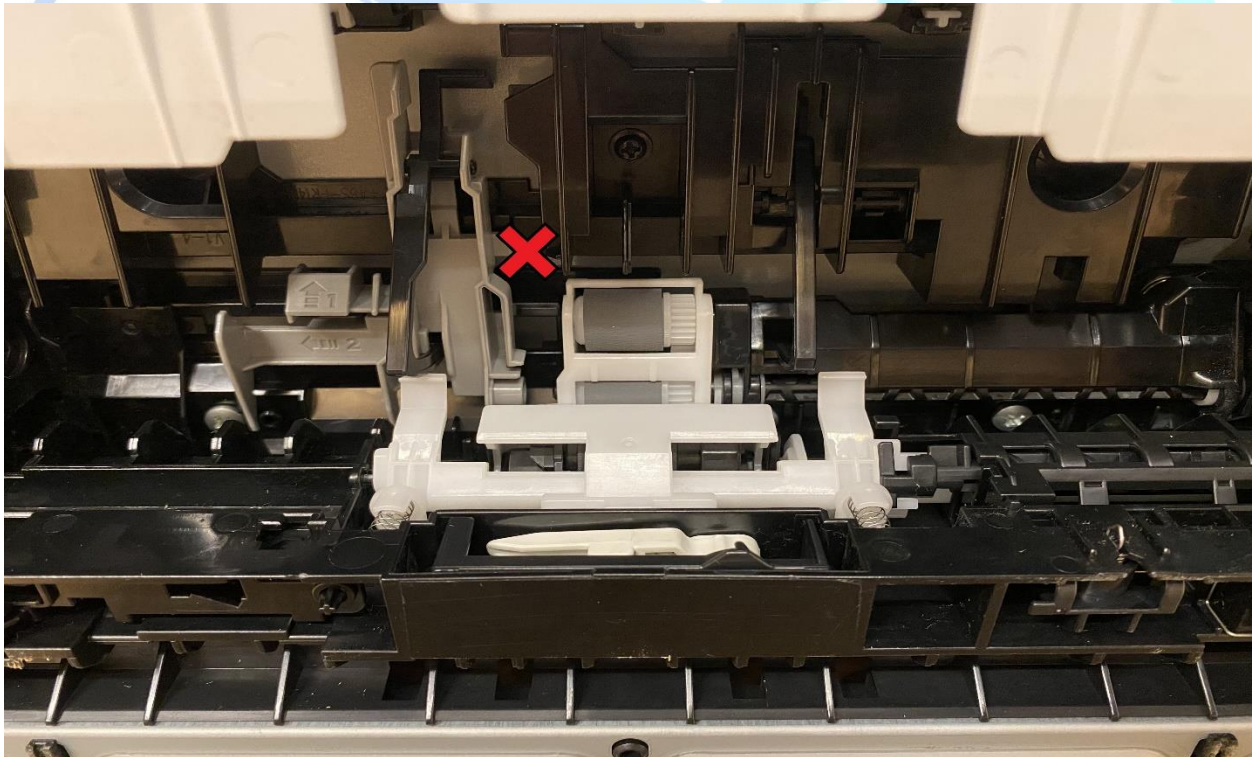
Figure 4: Duplex tray shown lowered and roller lock out of position:
