59.F0 Error

HP CP4025/CP4525/CM4540/M651/M680MFP

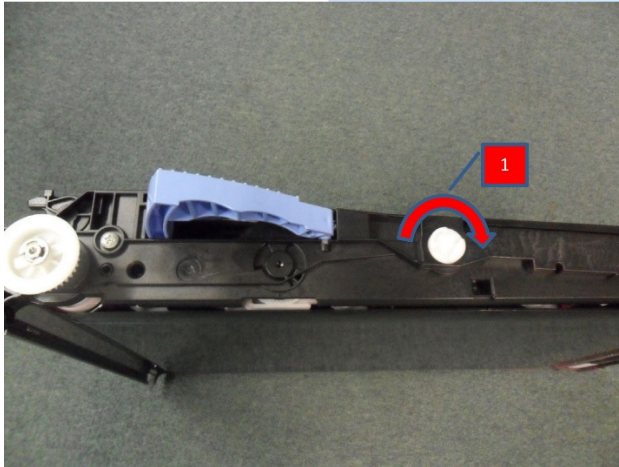
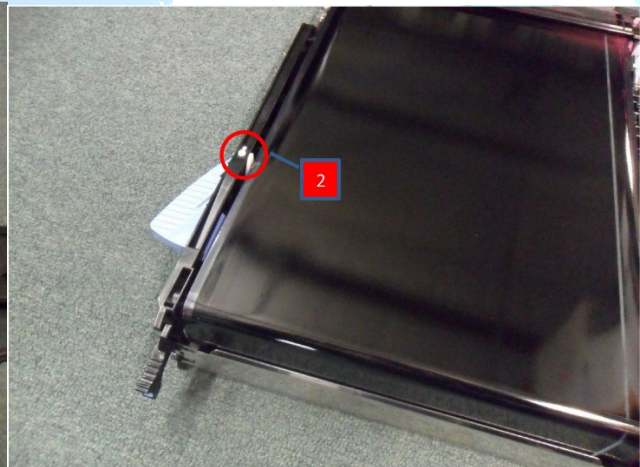
This error is primarily caused by a transfer alienation failure in which the ITB is stuck and unable to rotate, the SR9 sensor (the primary transfer roller disengagement sensor) has gone bad or the fuser drive assembly has failed.

1. Reseat the ITB.
2. If the issue persists, remove the ITB completely from the unit and manually test the ITB gear and flag.
3. Rotate the gear (1) and check that the flag actuates (2) when the white gear is turned.

4. If the ITB flag is broken or damaged, or if the flag does not move, replace the ITB.
5. If the ITB gear and flag are working properly, test the Primary transfer roller disengagement sensor SR9 (Sensor K) by using the MANUAL SENSOR TEST in the TROUBLESHOOTING MENU.
6. Remove the ITB and fuser assembly to locate Sensor SR9 (3) inside the fuser cavity.
