## 59.F0 Error

### HP CP4025/CP4525/CM4540/M651/M680MFP

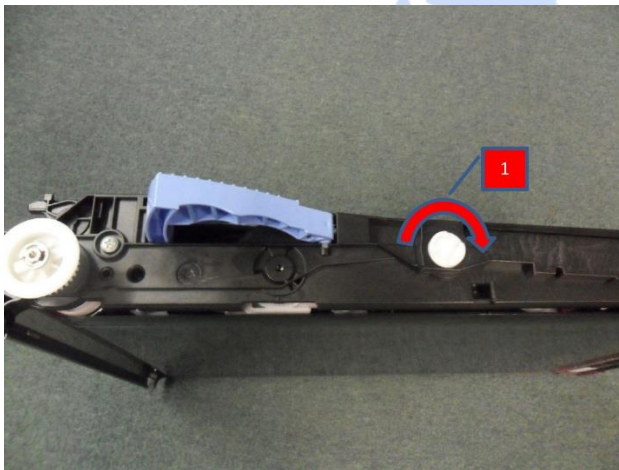
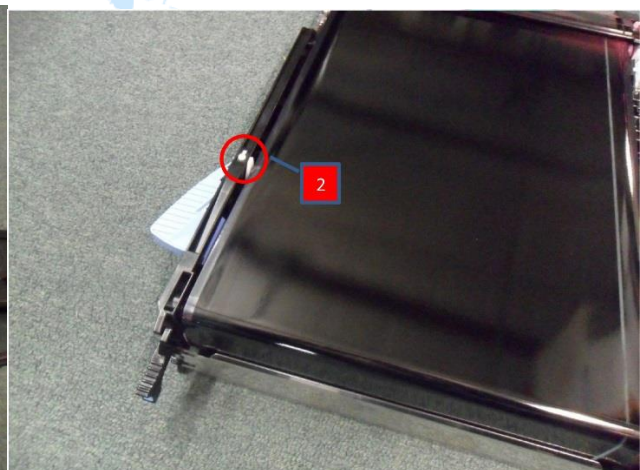
1. Reseat the ITB and power cycle the printer.
2. If the issue persists, completely remove the ITB from the unit and manually test the ITB gear and flag.
  - a. Rotate the gear (callout 1) and check if the flag actuates (callout 2) when the white gear is turned.

- b. If the ITB flag is broken, damaged, or if the flag does not move, replace the ITB (CE249A)

- c. If the ITB gear and flag are working properly and is not damaged continue to step 3
- 3. Test the Primary transfer roller disengagement sensor SR9 (Sensor “K”) by using the MANUAL SENSOR TEST in the TROUBLESHOOTING MENU.
  - a. NOTE: Before initiating this test, remove the ITB and fuser assembly from the unit to locate Sensor SR9 (callout 3) inside the fuser cavity.
