Control Panel Messages Document (CPMD)
HP LaserJet Enterprise M607, M608, M608nk, M609, HP LaserJet
Managed E60055-E60075, E60155-E60175 printers

10.WX.YZ error messages

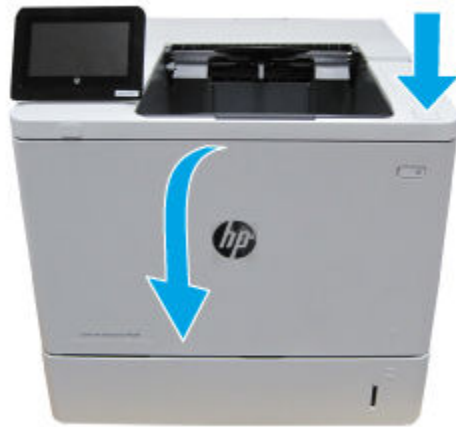
- 1. Check the toner cartridge.
 - a. Open the front door.

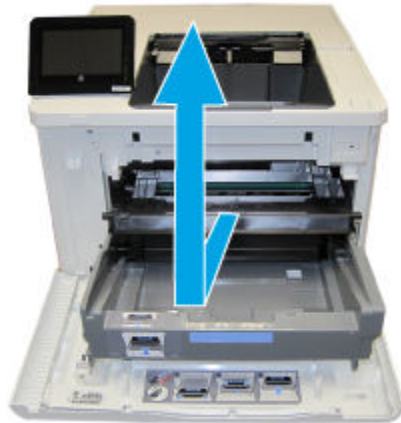
- c. Pull out and then up on the toner cartridge to remove it.

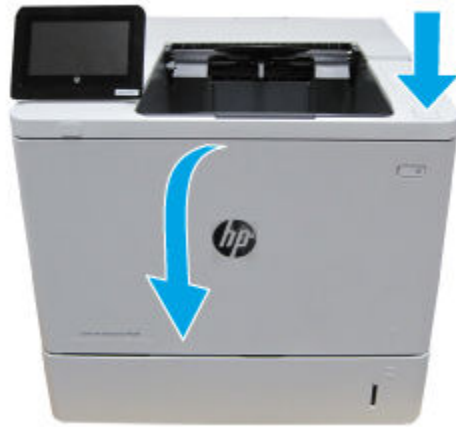
- 1. Check the toner cartridge.
 - a. Open the front door.

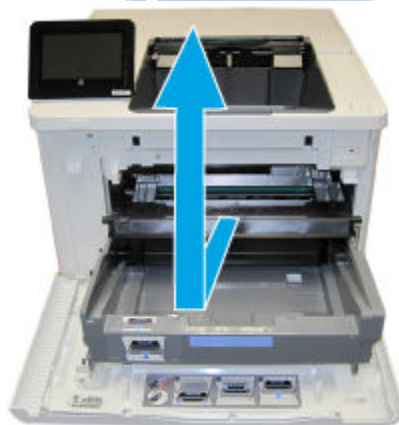
- c. Pull out and then up on the toner cartridge to remove it.

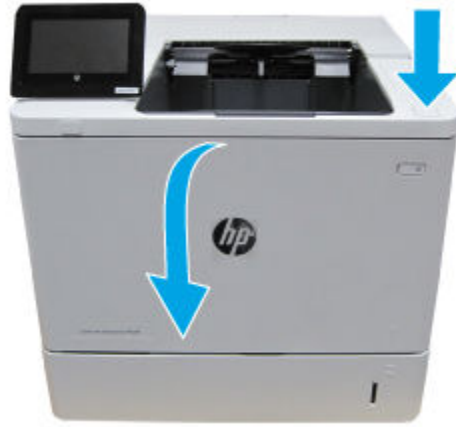
1. Check the toner cartridge.
 - a. Open the front door.

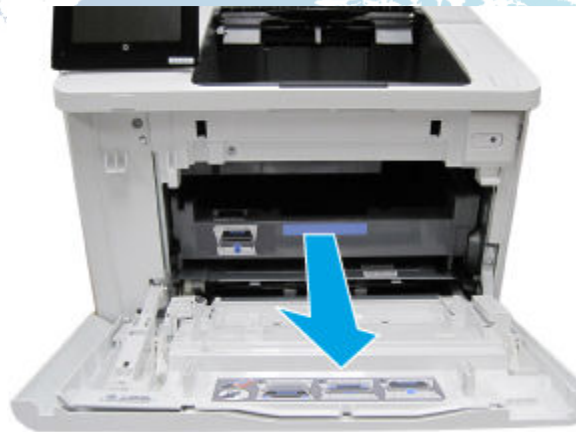
- b. Slide out the toner tray.

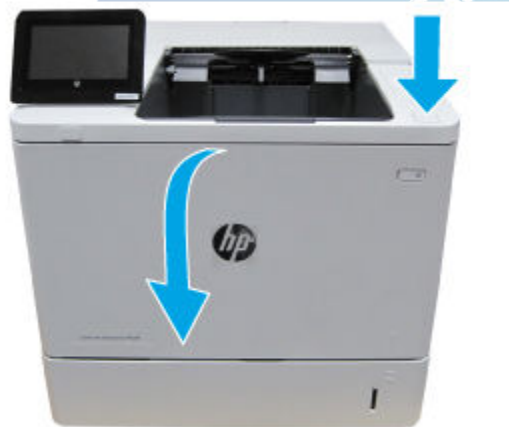
1. Check the toner cartridge.
 - a. Open the front door.

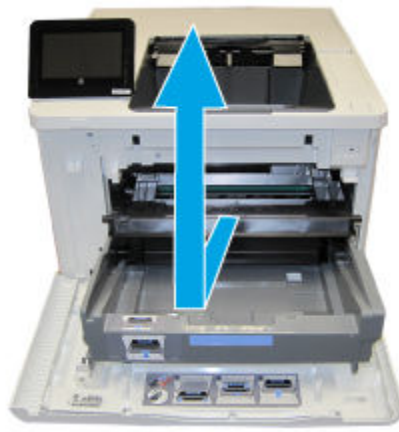
- c. Pull out and then up on the toner cartridge to remove it.

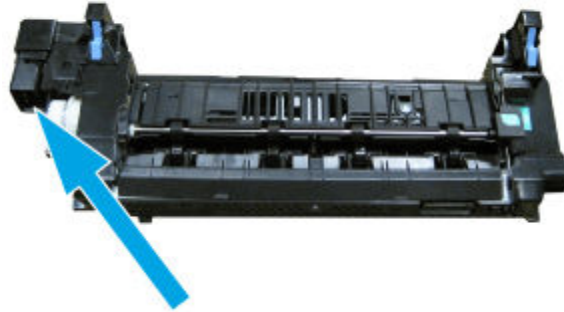
- b. Check the connection on the fuser

- c. If the fuser connector is damaged, replace the fuser.

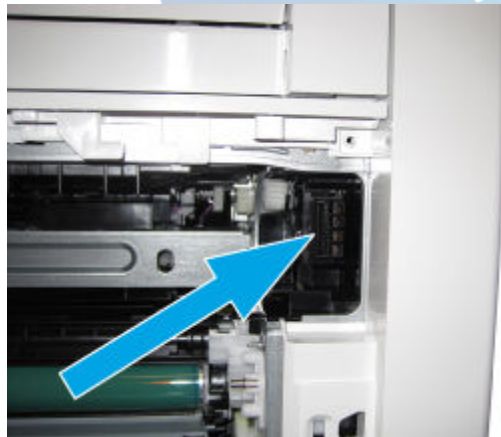
- d. Check the connection to the fuser in the printer.

- e. If the connector is damaged, elevate the case using the Standard Support Process.
 - f. Check connections J401 and J402 on the DC controller PCA.
4. If all connections are good, replace the DC controller PCA.

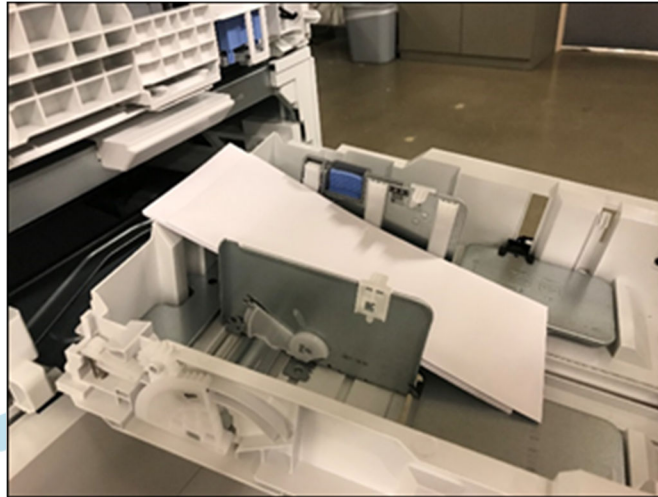
3. Remove the tray that holds the envelope feeder cassette by pulling up and lifting slightly.
4. If any envelopes have started to feed, remove and reinsert the envelopes.

A partially fed envelope

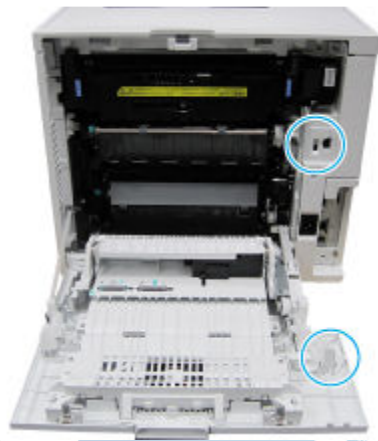
1. Close the rear door to allow the printer to attempt to clear the jam.
2. Check the projection part on the rear door that defeats the rear door interlocks. If broken replace the rear door assembly.

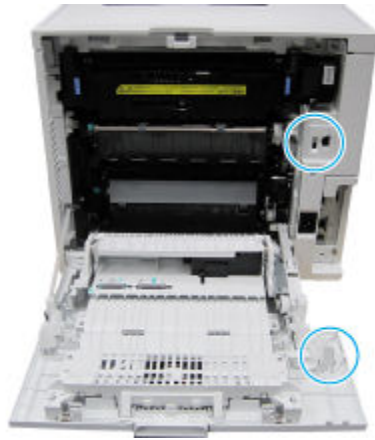
3. Check SW1 using manual sensor test.
 - a. From the home screen on the printer control panel, touch “Support Tools”.
 - b. Open the following menus:
 - Troubleshooting
 - Diagnostic Tests
 - Manual Sensor Test
 - c. Select from the following tests:
 - All Sensors , Engine Sensors
 - Done (return to the Troubleshooting menu)
 - Reset (reset the selected sensor’s state)
 - d. Test SW1 using folded paper or another object to defect the interlock. If the switch test fails, replace the laser shutter assembly.

Before replacing any parts check connector J321 on the DC controller.

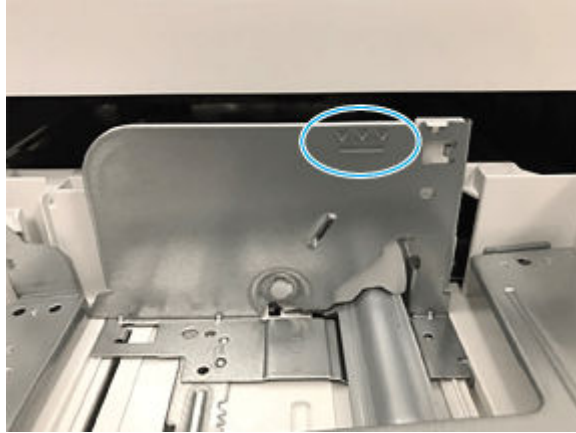
Paper height guides

8. Ensure that the paper tray meets the tray capacity specifications or the stack of paper in the tray is not above the fill mark (line below the three triangles) as indicated in the image.

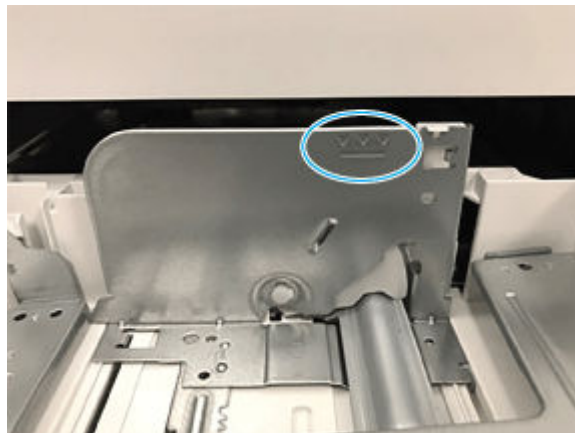
Paper height guides

8. Ensure that the paper tray meets the tray capacity specifications or the stack of paper in the tray is not above the fill mark (line below the three triangles) as indicated in the image.

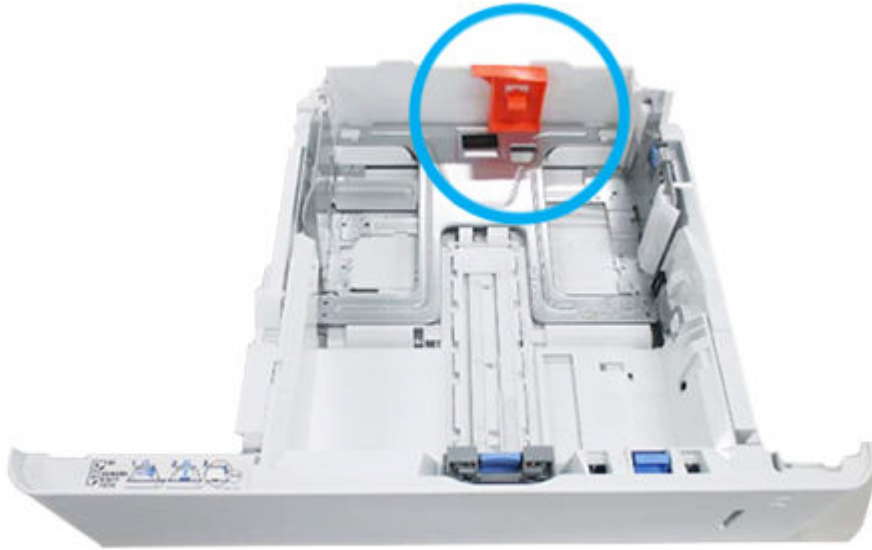
1. Pull the specified tray completely out of the printer to remove it.
2. Ensure that the protective orange plastic shipping locks are removed from tray, if present.

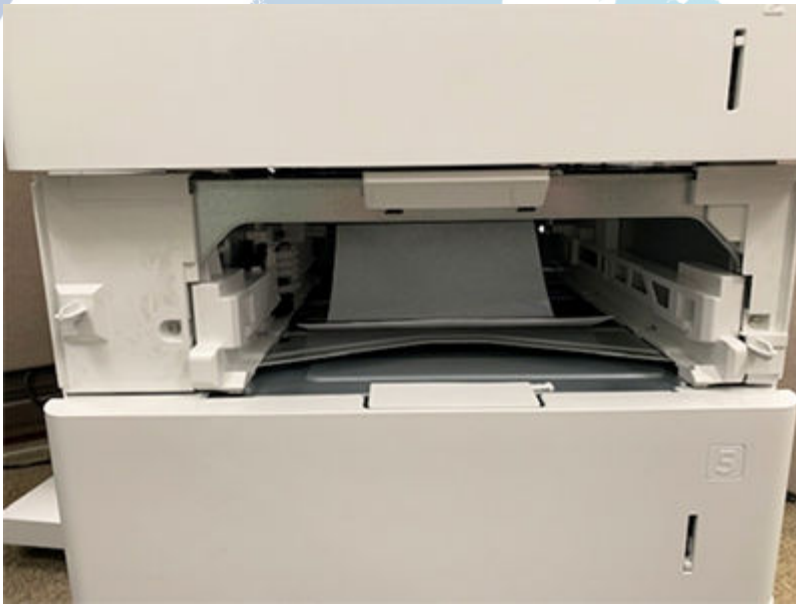
3. Remove any jammed or damaged sheets of paper from the opening of tray or tray assembly.
4. Check for any jammed or damaged sheet of paper inside the printer. If paper is present, remove it from the printer.

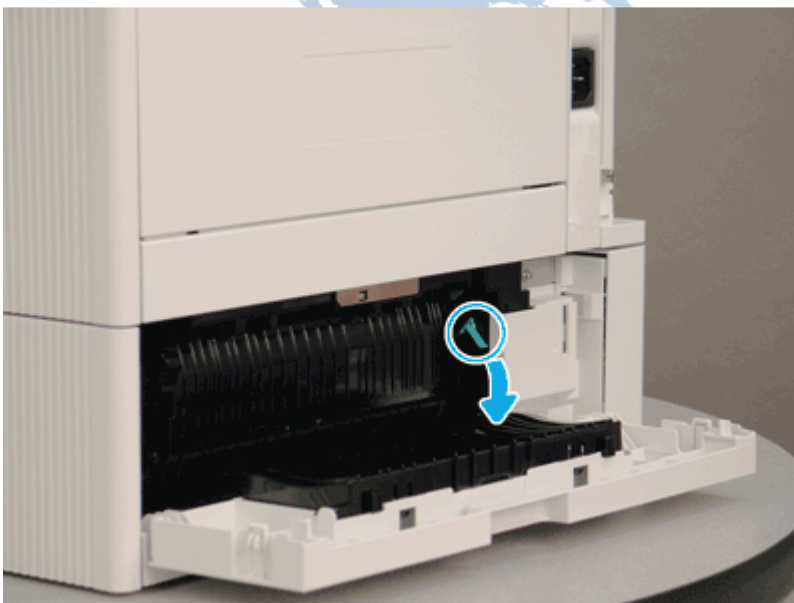
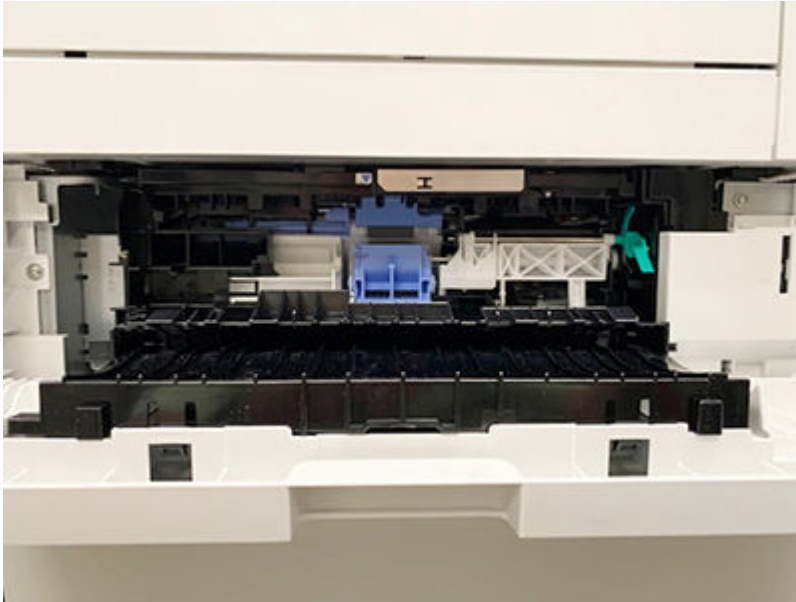
7. Open the rear door to the optional paper feeder and push the green tab (jam access door) on the right side down to expose the pickup rollers. Clear any paper present or obstructions in the paper path.

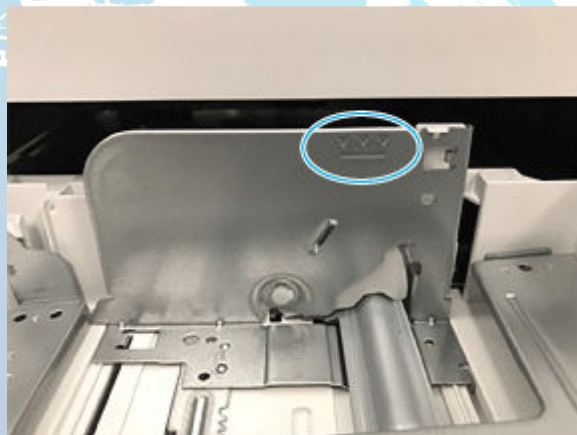
1x550 tray fill mark example 1

12. Ensure that the paper in the tray meets the tray capacity specifications or the stack of paper in the tray and is not above the fill mark (line below the three triangles) as indicated in the image.

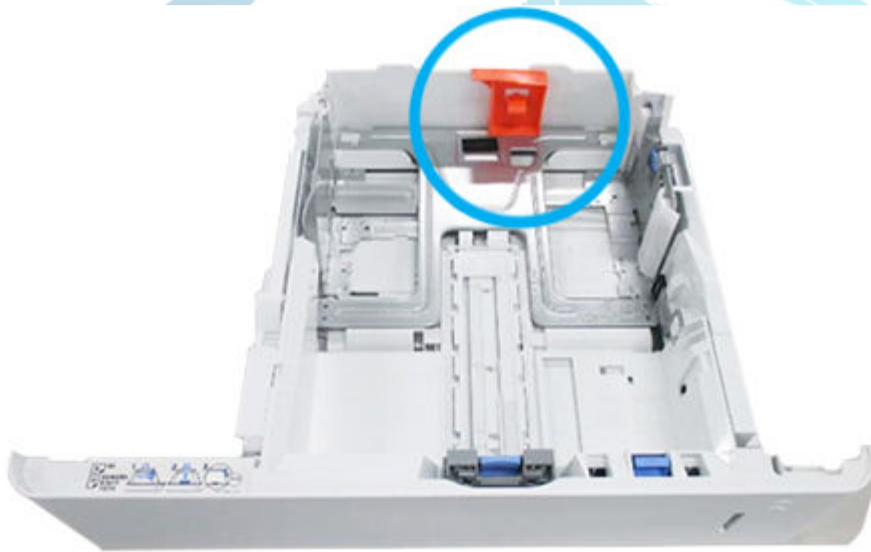
1. Pull the specified tray completely out of the printer to remove it.
2. Ensure that the protective orange plastic shipping locks are removed from tray, if present.

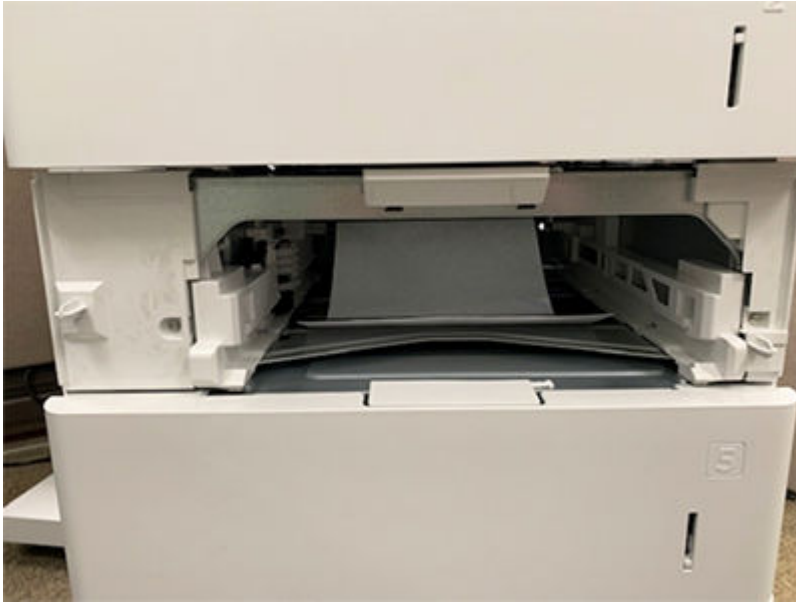
3. Remove any jammed or damaged sheets of paper from the opening of tray or tray assembly.
4. Check for any jammed or damaged sheet of paper inside the printer. If paper is present, remove it from the printer.

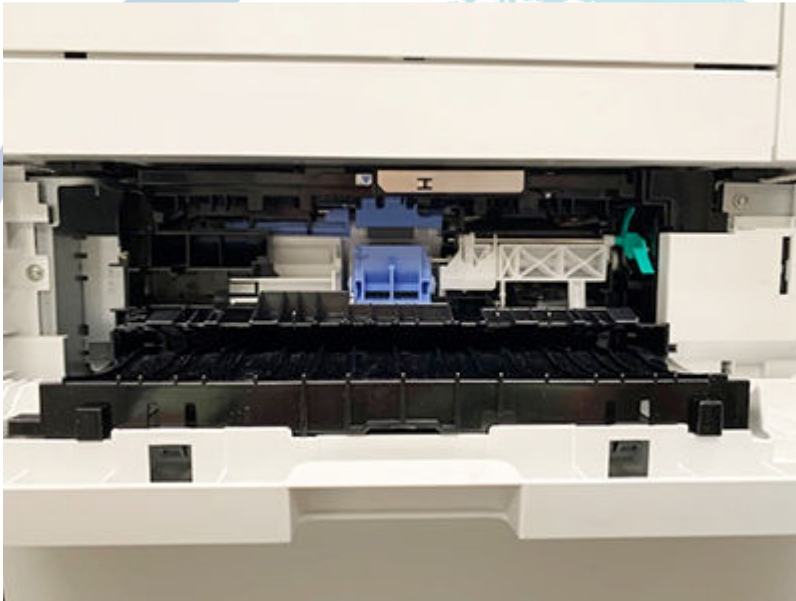
6. Open the rear door to the optional paper feeder and push the green tab (jam access door) on the right side down to expose the pickup rollers. Clear any paper present or obstructions in the paper path.

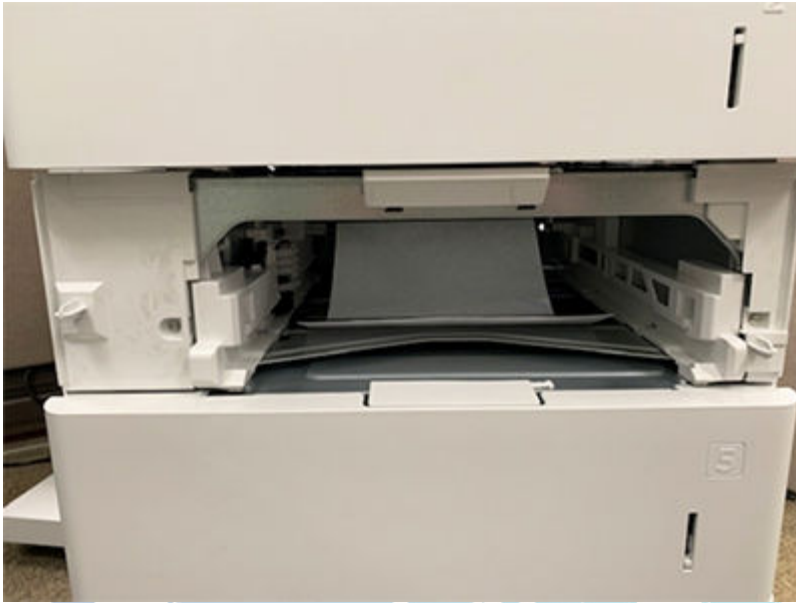
4. Check for any jammed or damaged sheet of paper inside the printer. If paper is present, remove it from the printer.

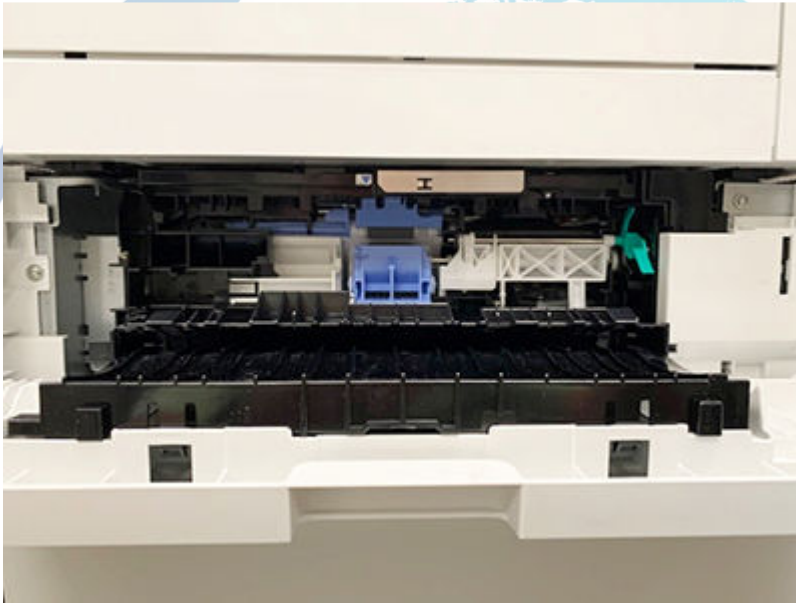
6. Open the rear door to the optional paper feeder and push the green tab (jam access door) on the right side down to expose the pickup rollers. Clear any paper present or obstructions in the paper path.

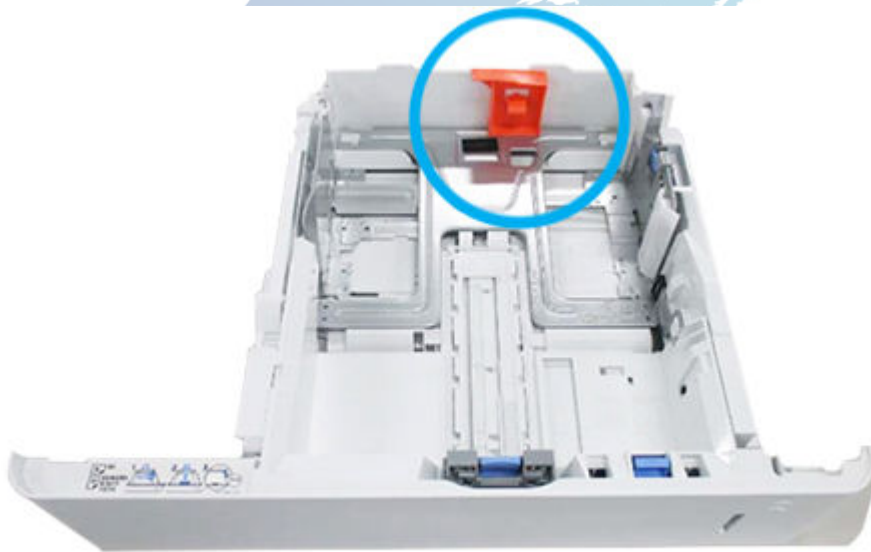
1. Pull the specified tray completely out of the printer to remove it.
2. Ensure that the protective orange plastic shipping locks are removed from tray, if present.

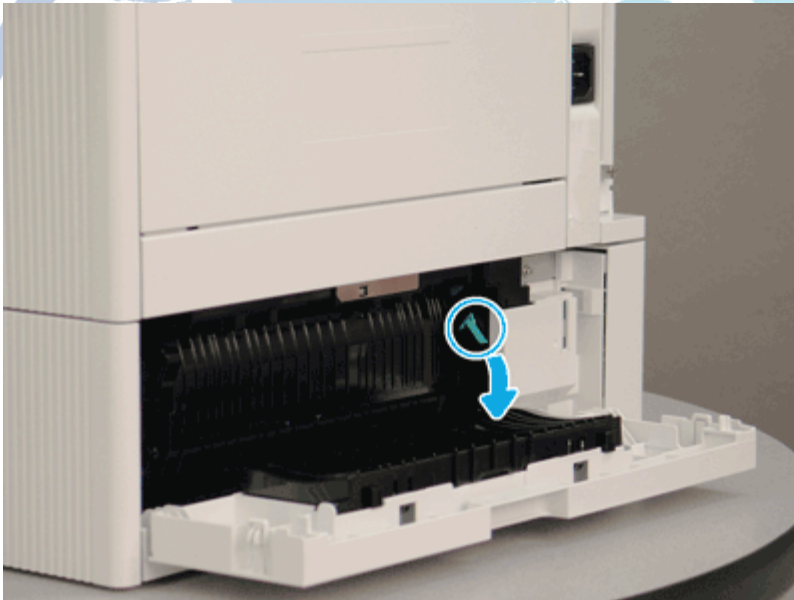
7. Open the rear door to the optional paper feeder and push the green tab (jam access door) on the right side down to expose the pickup rollers. Clear any paper present or obstructions in the paper path.

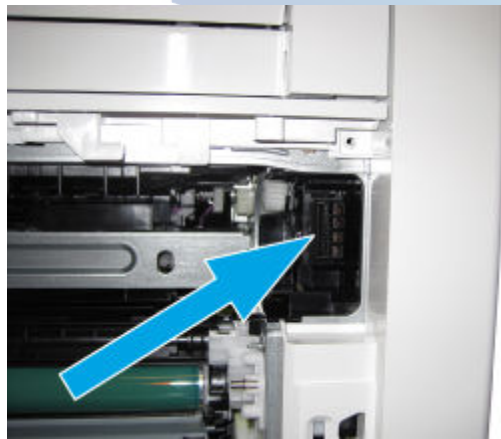
- d. Check the connection to the fuser in the printer.

- e. If the connector is damaged, Elevate the issue using the Standard Support Process.
 - f. Check connections J401 and J402 on the DC controller PCA.
4. If the fuser has not been replaced, replace the fuser.

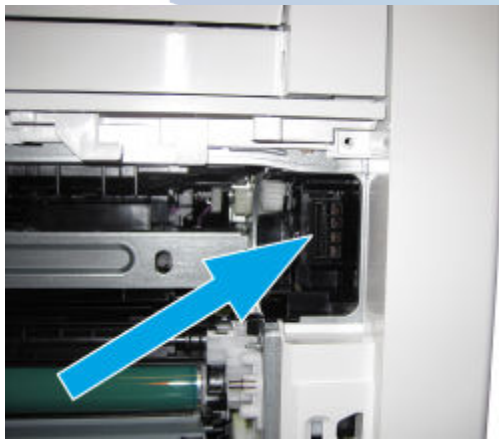
- d. Check the connection to the fuser in the printer.

- e. If the connector is damaged, Elevate the issue using the Standard Support Process.
 - f. Check connections J401 and J402 on the DC controller PCA.
4. Check the paper type setting in the printer control panel menus and in the print driver. Ensure that the settings match and are correct for the type of paper being used.
 5. If the error persists, replace the low voltage power supply (LVPS).
